Façade transformation at Canterbury Academy

PROJECT:

The Canterbury Academy
Architect: Prima Systems (SE) Ltd
Contractor: Prima Systems (SE) Ltd
Value: £472,000

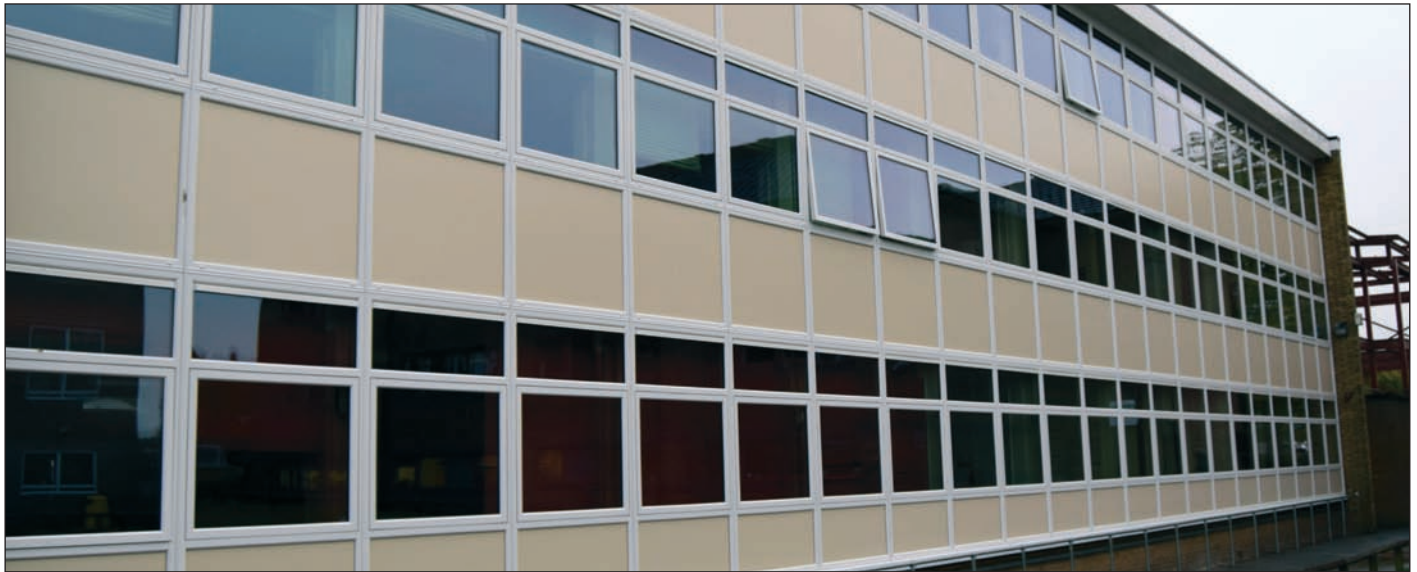
After refurbishment ▲

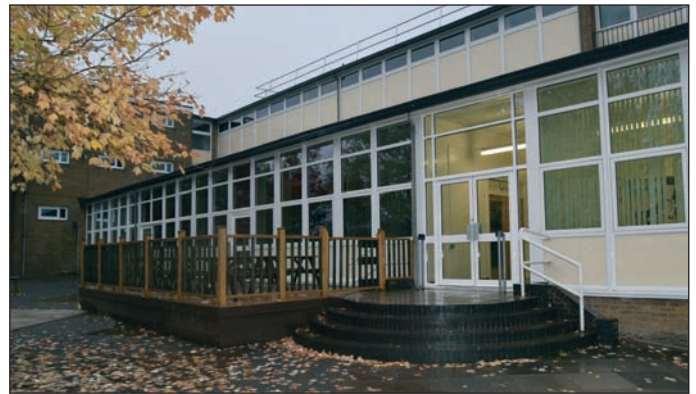
The façade investigation report raised several major concerns – over 60% of the windows exhibited warped sashes resulting in draughts and heat loss, over half of the windows had missing putty beads and around 20% of the window panes were broken.

There were also clear signs of water penetration and the fire breaks to the existing floor slabs were missing. Calculations also revealed that there was insufficient ventilation in the classrooms.

Before refurbishment ▲

The design solution was to insert a steel reinforced PVCu double glazed curtain wall window system between the existing structural steel Crittall window mullions.

The Rehau Total 70 PVCu window system was then inserted in between the steel mullions with solar control glass added to minimise solar heat gain and help control glare.

Plastisol HP200 steel insulated panels were added to improve the overall thermal and visual performance of the façade.
