Case study: The Canterbury Academy

Prima's support helps to secure CIF funding for facade transformation at Canterbury Academy

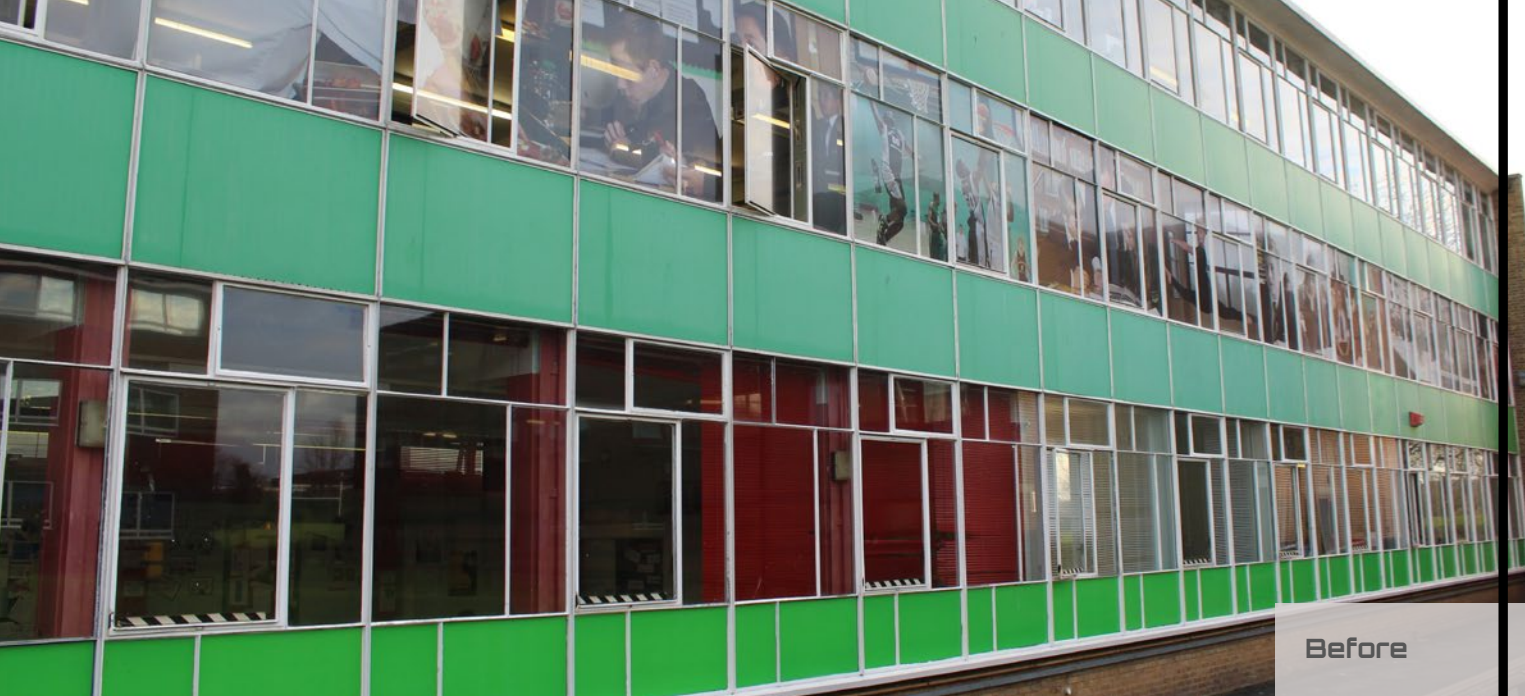
Before

The existing façade dated back to the original build in 1956 and was constructed using 'Crittall' style steel framing to form an outer skin which was then filled with a mixture of single glass panes and cladding panels.

The façade investigation report raised several major concerns – over 60% of the windows exhibited warped sashes resulting in draughts and heat loss, over half of the windows had missing putty beads and around 20% of the window panes were broken. There were also clear signs of water penetration and the fire breaks to the existing floor slabs were missing. Calculations also revealed that there was insufficient ventilation in the classrooms.

The design solution was to insert a steel reinforced PVCu double glazed curtain wall window system between the existing structural steel Crittall window mullions. The Rehau Total 70 PVCu window system was then inserted in between the steel mullions with solar control glass added to minimise solar heat gain and help control glare. Plastisol HP200 steel insulated panels were added to improve the overall thermal and visual performance of the façade.
